Fractured Metallic Tracheostomy Tube: Report of a Fractographic Study

Objective: To investigate the cause of a broken metallic tracheostomy tube.

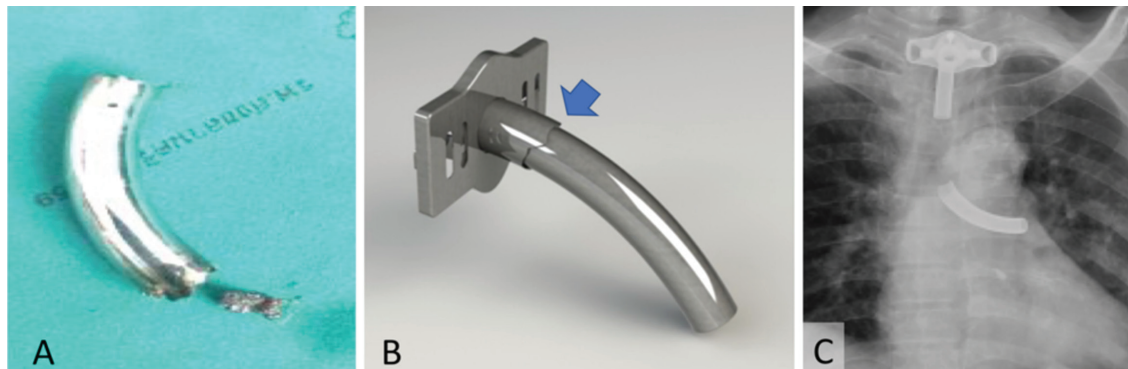
Here we report comprehensive physical studies of a tracheostomy tube from a 90-year-old female patient whose tube fractured. The case was a bed-ridden cerebrovascular accident patient who developed persistent choking and cyanosis. A chest X-ray revealed a broken tracheostomy tube with its outer cannula slipped into the left main bronchus. The foreign body was successfully removed by a balloon catheter withdrawal technique. The tube had been in use for 1 year. The aim of this study was to evaluate the physicochemical properties of a broken tracheostomy tube to help lead to a better understanding of the fracture mechanism in such cases.

Figure 1 (A) Macroscopic picture of the distal part of the outer tube retrieved from the bronchus; (B) picture of a new fractured tracheostomy indicating the fracture site (arrow); (C) chest x-ray showing the site of the dislodged outer tube in the left main bronchus.

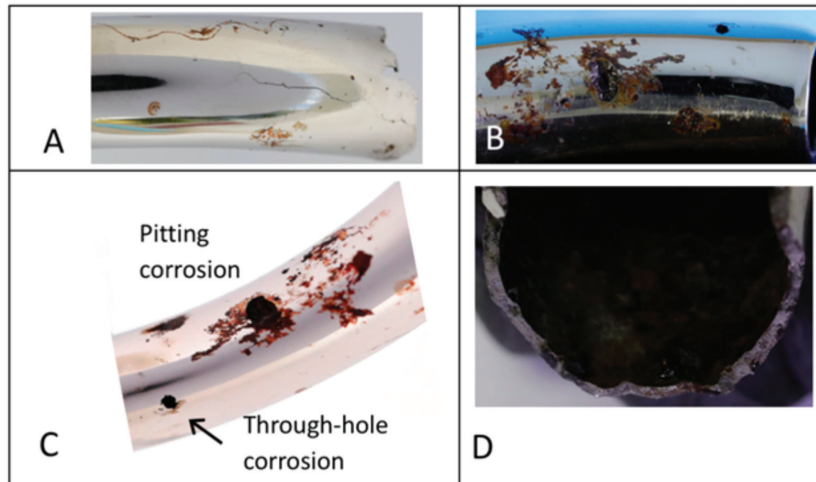
The fractured part of the tracheostomy tube was about 11.5 mm outer diameter (OD), 0.6 mm thick and 55 mm long. It was curved with a polished surface. After cleaning by immersion in absolute alcohol and soft brushing, the surface was seen to be stained with hard brown deposits. Two cracks could be seen, one 22 mm in length longitudinally with branching tips on the outer curve and the second 12 mm in length parallel to the larger one (Figure 2A). There was a corroded pit of about 4x2.5 mm in area and 0.5 mm in depth near the inner curvature (Figure 2B), with a hole right through the tube of 1 mm in diameter (Figure 2C), apparently originating from the internal surface as the external surface was otherwise uncorroded in this area. The fracture was a brittle type as there were no gross deformities or uneven edges. There was thick brown staining on the inner surface of the device (Figure 2D).

Figure 2 (A) Multiple longitudinal cracks and deposits on the external surface. (B) Pitting corrosion with deposits on the external surface. (C) A full-thickness corrosion hole on the outer curvature. (D) Brittle fracture with no deformation of the tube

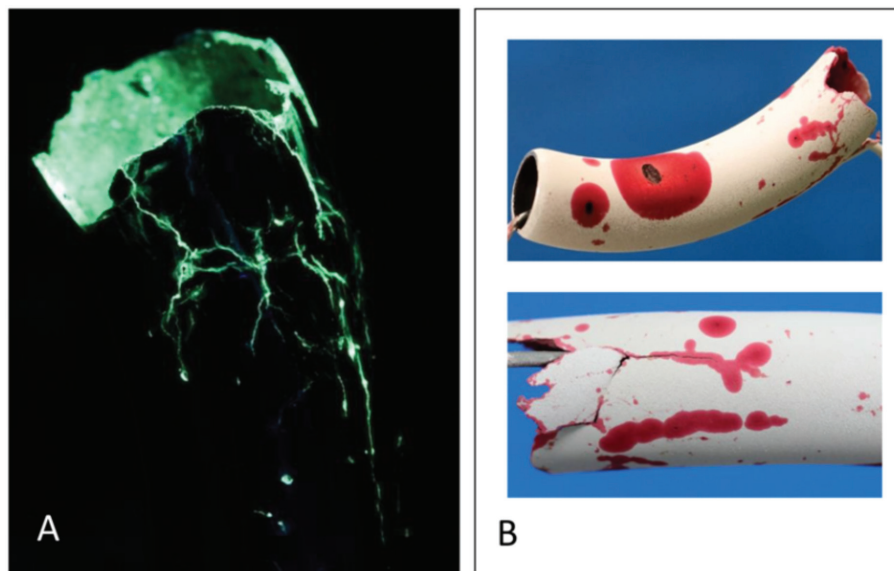
By the application of both a fluorescent liquid penetrant and visible dye penetrant, discrete longitudinal

linear indications of cracking were found clustered close to the fracture site (Figure 3).

Figure 3 Picture from the liquid penetrant test and fluorescent dye penetrant test at the external surface. (A) With the fluorescent dye penetrant at the external surface, several longitudinal linear cracks were detected around the fracture. (B) With the liquid penetrant test; visible dye penetrant, at the external surface, several linear and round markings were detected.

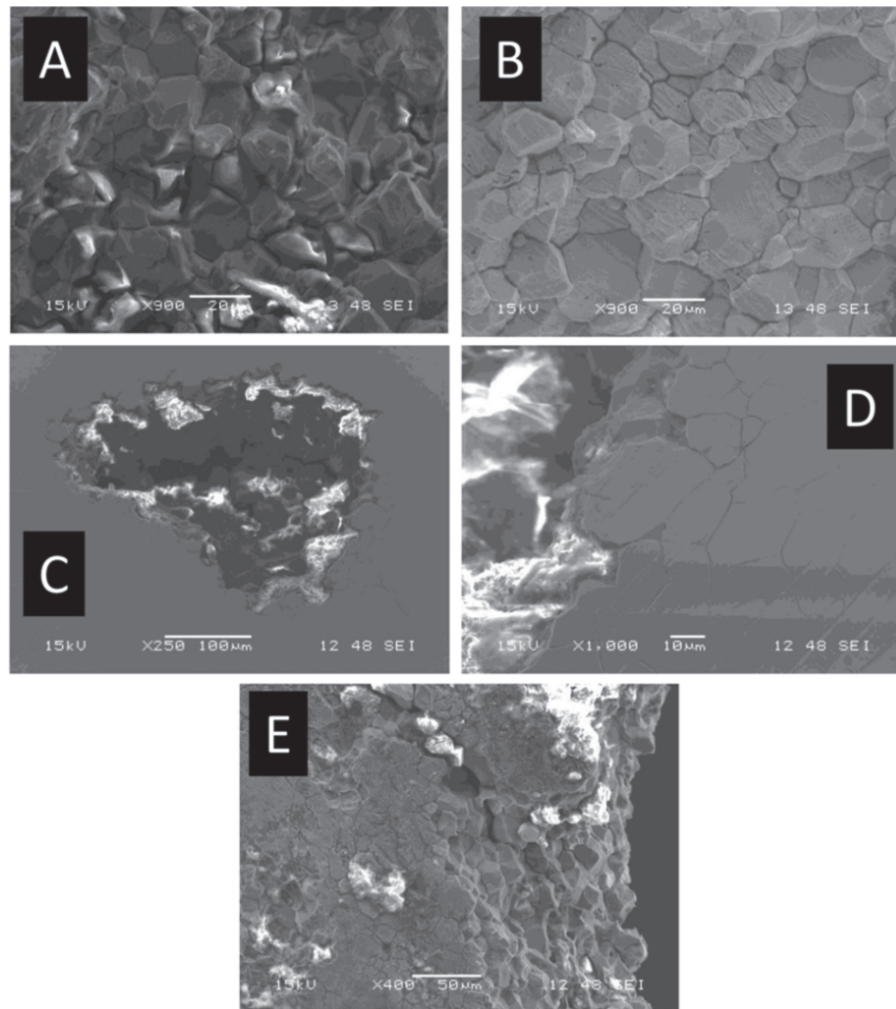
Investigation by SEM showed intergranular corrosion along the fracture site. Cracks could be seen along the grain boundary (Figure 4).

Figure 4 (A–B) Scanning electron microscopy (SEM) images showing the intergranular corrosion effects at the fracture surface. (C–D) SEM images of the external surface near the pit with intergranular attack. (E) The internal surface close to the fracture also shows inter-granular corrosion effects.

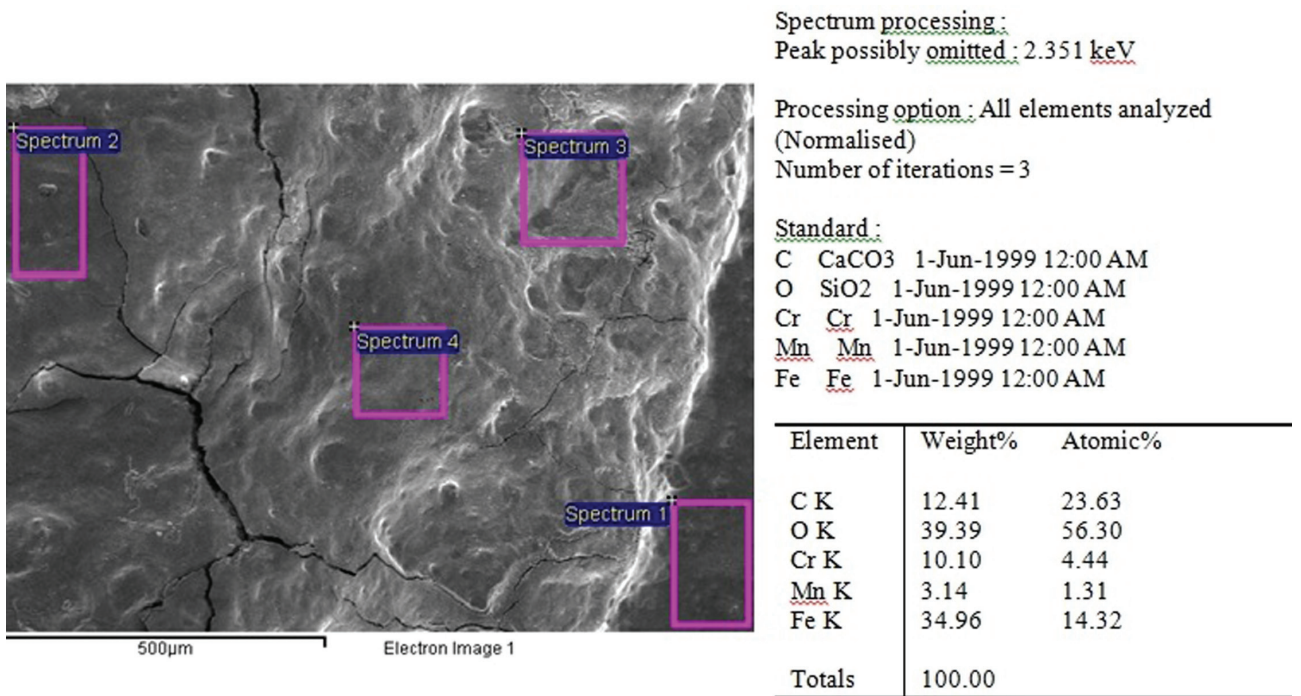
Chemical composition analysis of deposits from the inner surface using EDX Spectroscopy method indicated that the deposits were a ferrous-rich oxide. There were also significant amounts of carbon, manganese, phosphorus and calcium (Figure 5).

Figure 5 Energy dispersive X-ray spectroscopy report of deposits from the inner surface
